***DRIVEGUARDIAN™***

## Stern Drive Reliability

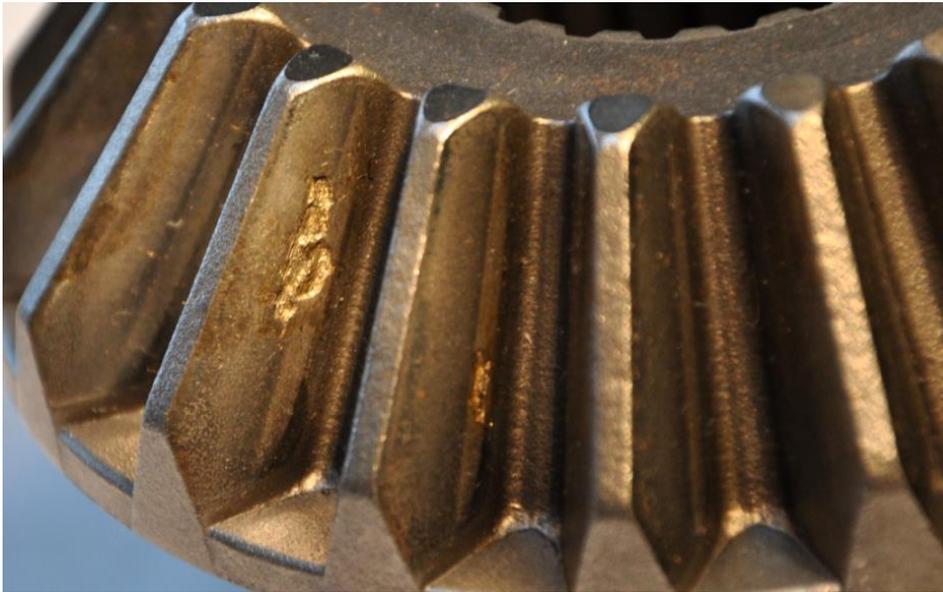
The best case scenario resulting from repeated torque spikes is that the tremendous stress on the gears will eventually lead to damage on the face of the teeth as shown in (Figure 1). This damage will inevitably increase in size and propagate until the gear fails. Evidence of this shock loading is slivers of metal appearing on the drain plug magnet as the mating surfaces of the teeth break off. Once this process begins, the only remedy will be a drive rebuild.

**Figure 1: Tooth Damage on a Mercury Racing SSMVI Pinion Gear**

The worst case scenario is that the torque spike is severe enough to break a tooth off one of the gears and become jammed between the gears, which will most likely cause the housing to break open and result in catastrophic failure.

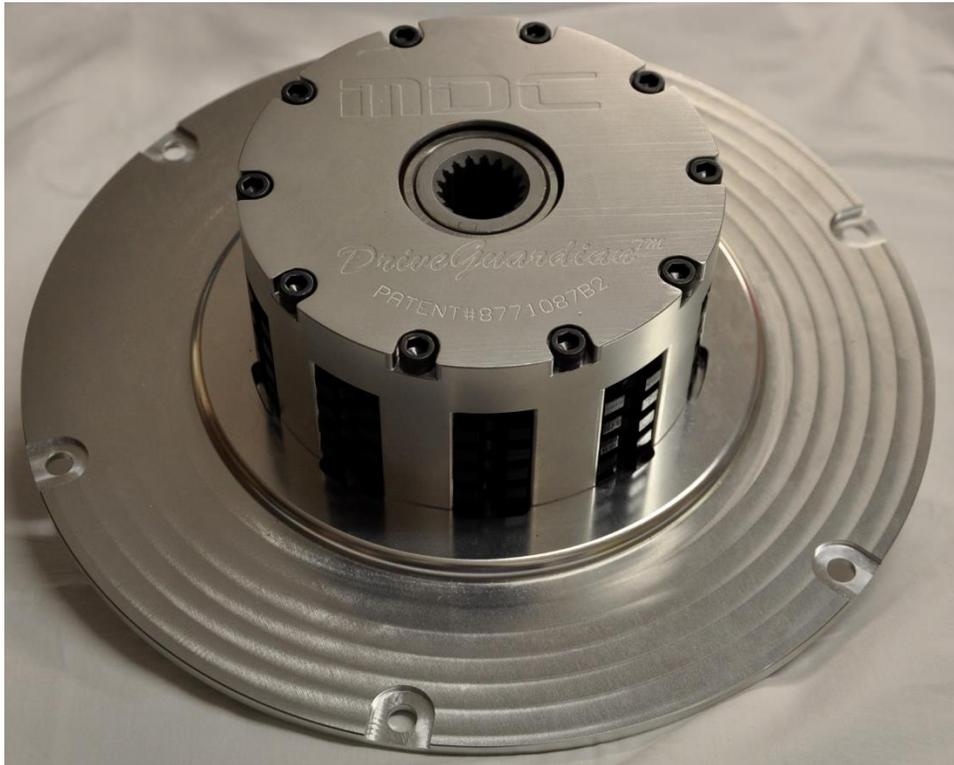
DriveGuardian replaces the existing coupler or drive-plate that connects the engine to the stern drive's input shaft or driveline in staggered installations. Installation is straightforward and can be performed by any reputable dealer or experienced boat owner. DriveGuardian is suitable for single and multi-engine installations and is compatible with most stern drives on the market. Figure 2 is a DriveGuardian for Bravo style drives such as Mercury Racing Bravo One XR™, IMCO SC, IMCO SCX & B-Max.

Figure 2: DriveGuardian Bravo

DriveGuardian is a torque-limiting coupler designed to absorb the excess torque that exceeds a preset value. Since DriveGuardian's torque rating is designed higher than the engine's output, there will be zero impact (no slip) under normal operating conditions. Going from idle to full throttle to climb onto plane will never cause DriveGuardian to activate and will never impact performance.

The torque required to force DriveGuardian to activate is nearly identical to the torque that the coupler will transmit while slipping. In other words, DriveGuardian will always transmit the engine's torque to the drive even while protecting it from overloading. This unique aspect of the coupler's design allows it to continue to apply regulated torque to the drive, and makes it impossible for the operator to detect DriveGuardian's operation.

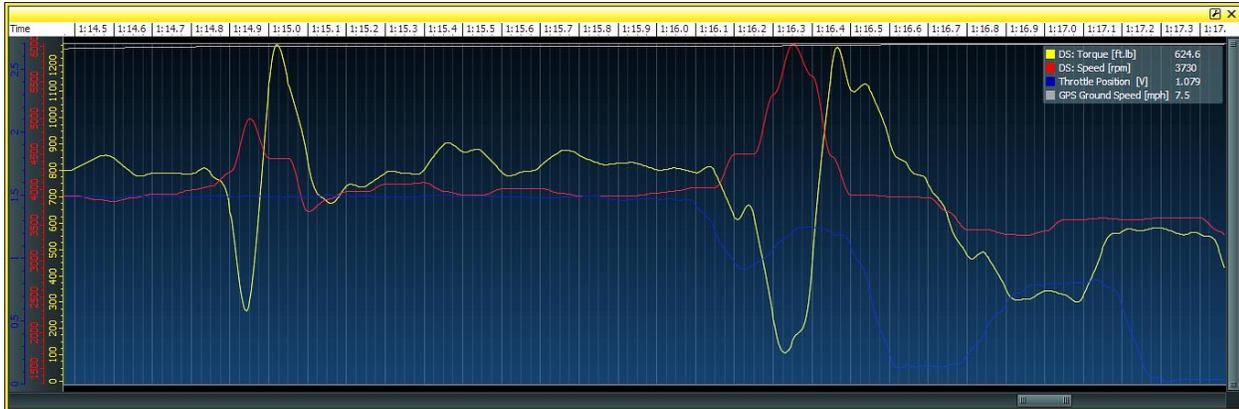
Figure 3: Three Second Snapshot Shaft Dyno Data

At a test boat speed of approximately 65MPH, two torque peaks (yellow plot line) are visible in the Shaft Dyno output in Figure 3. Both of the spikes in Figure 3 are 60% more than the engine’s peak output and beyond the stern drives maximum input rating of 1,160 ft-lbs. It is interesting that the throttle position (blue plot line) at the peak of the torque-spike had very little effect on the severity of the spike. This makes sense if you recognize that the torque-spikes are a direct result of having a large mass (engine, flywheel, coupler, drive shaft, U-joints, gear sets, etc.) rotating at high RPM (red plot line) and then being suddenly slowed down by the propeller.

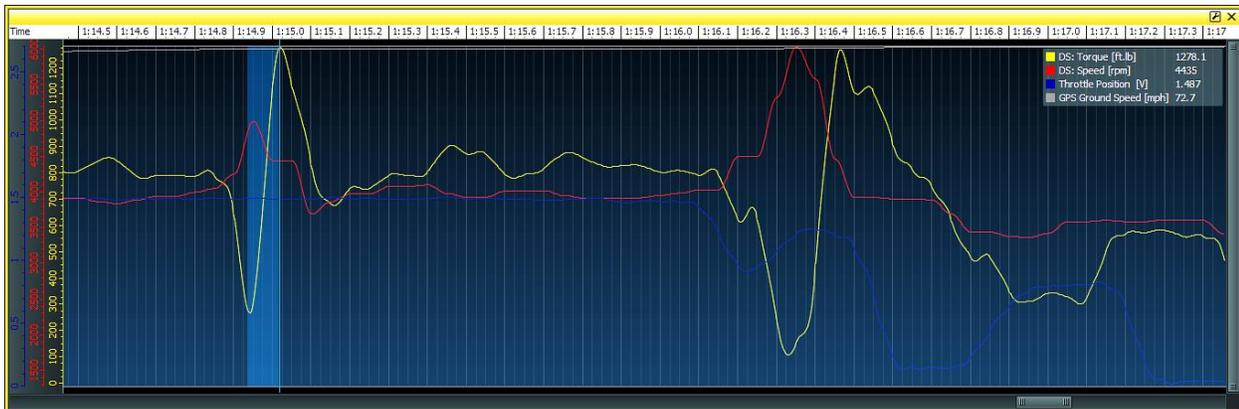
Figure 4: Shaft Dyno Plot: 1,278 ft-lb Torque Spike

In the highlighted area of Figure 4, a drop of 193 RPM, (red plot line) resulted in the torque jumping from 263 ft-lbs (propeller nearly out of the water) to a spike of 1,278 ft-lbs (yellow plot line) in 0.08 seconds. In this example the event duration is so short that the operator was unable to compensate and the throttle position remained essentially constant at 55% open (blue plot line).

Table 1 is the results of a mathematical model of the 1,278 ft-lb torque spike that is highlighted in Figure 4. Based on the 1.52:1 gear ratio for the drive, you can see that the propeller shaft sustained an even greater torque spike of 1,918 ft-lbs.

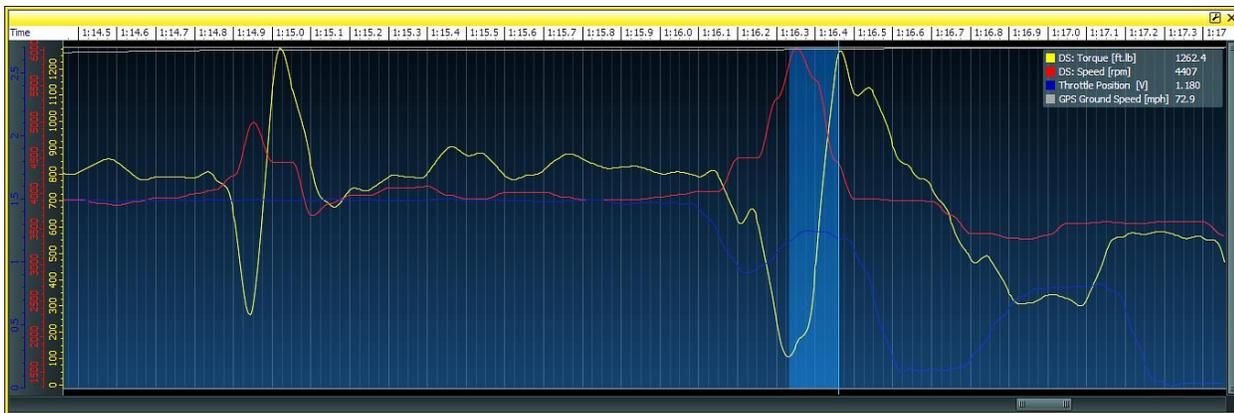
Figure 5: Shaft Dyno Plot: 1,262 ft-lb Torque Spike

In the highlighted area in Figure 5, a drop of 863 RPM (red plot line) resulted in the torque (yellow plot line) jumping from 103 ft-lbs (propeller out of the water) to a spike of 1,262 ft-lbs in 0.129 seconds. Operator reaction time was relatively good with the throttle position (blue plot line) dropping just before the propeller left the water and then increasing to 44% in less than a 1/10<sup>th</sup> of a second before torque spike.

As a great example of rotational inertia, please notice that immediately following the highlighted torque spike in Figure 5, the throttle position was held at 10% for more than 2/10ths of a second. At this point the propeller is in the water and the torque spike is gradually dissipating, but the RPMs barely change for a full the full 2/10ths of a second, even with the throttle practically closed.

Table 2 is a mathematical representation of the highlighted portion of the plot in Figure 5. With just under seven propeller revolutions, the boat travelled approximately fifteen feet during the synchronization event.

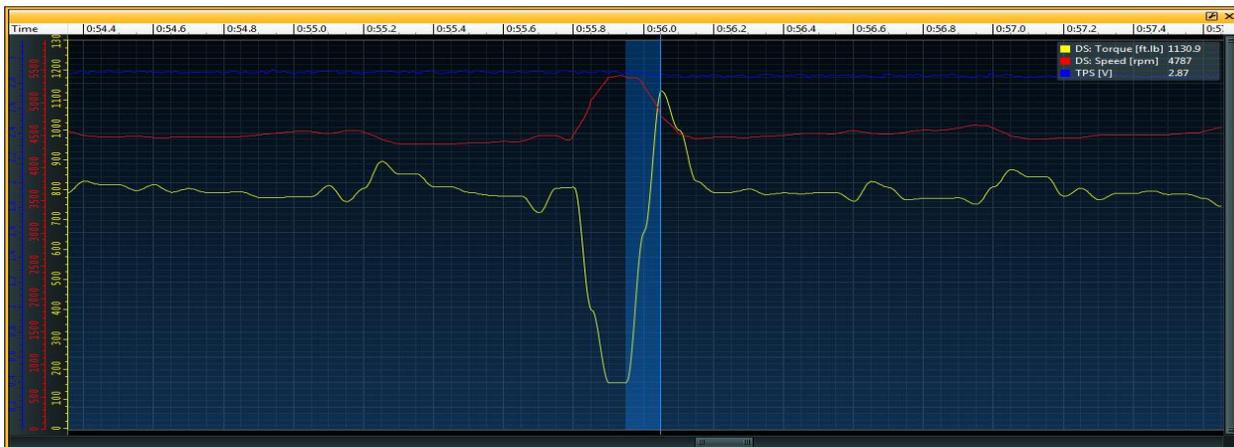
Figure 6: Shaft Dyno Plot: DriveGuardian Limiting Torque Spike to 1,130 ft-lb.

In the highlighted area of Figure 6, a drop of 621 RPM (red plot line) resulted in the torque jumping from 155 ft-lbs (propeller nearly out of the water) to a DriveGuardian regulated spike of 1,130 ft-lbs (yellow plot line) in 0.095 seconds. Boat speed was 85MPH and the throttle remained approximately 85% open (blue plot line). So, with an RPM drop of more than 3X the highlighted area of Figure 4 and over roughly the same period of time, the torque spike was still 12% lower. This plot clearly indicates how effective DriveGuardian is at regulating torque spikes.

Using the same mathematical model as the previous test and based on the data from the DriveGuardian test, Table 3 shows that it would require an ***Inertia-Induced Torque of 3,316 ft-lbs*** to decelerate the rotating mass of the engine from 5,408 RPM to 4,787RPM in .095 seconds. While some of this energy would have been dissipated by the propeller, clearly the data proves that DriveGuardian regulated the torque spike to a preset value of 1,130 ft-lbs and protected the stern drive from a damaging torque spike.

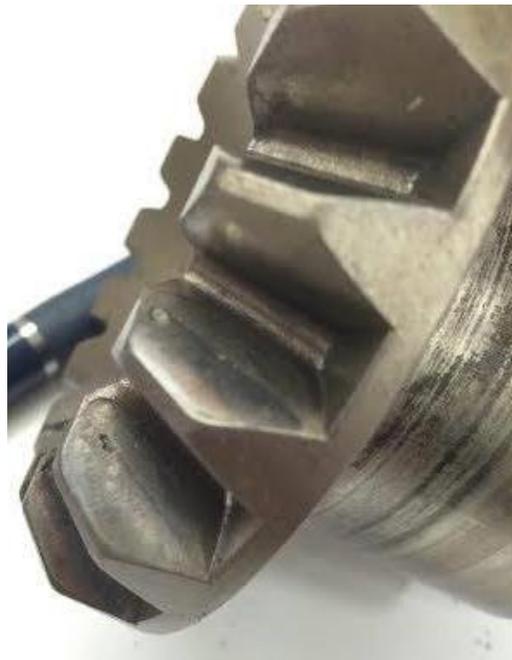
Prior to installing DriveGuardians, Team Saris was replacing their Bravo XR upper gears every 3-4 races due to excessive pitting on the face of the teeth. Evidence of the pitting was showing up as metal particles on the lower drain plug magnet. Once the pitting starts it will propagate rapidly leading to complete gear failure and must be replaced immediately.

Figure 8: Team Saris Racing Engines, Bravo XR Upper Gear – 3 Races with Stock Coupler

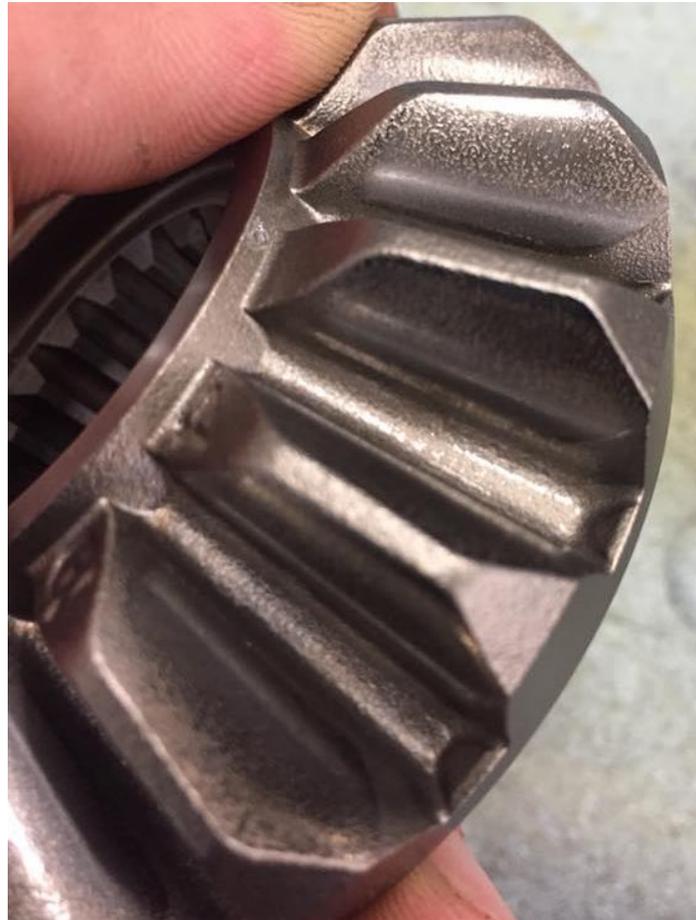
Since installing DriveGuardians, the team runs an entire season on their drives and the only maintenance that has been required is to change the Mercury Racing Hi Performance gear lube. Below is a stock Bravo XR gear that Team Saris ran for 12 races across two seasons. This gear shows normal wear with no evidence of pitting and has since been re-installed in the drive. We will report on it's condition after the next inspection point.

Figure 9: Team Saris Racing Engines, Bravo XR Upper Gear – 12 Races with DriveGuardian
